JONES LAKE DAM

OREGON COUNTY, MISSOURI

MO 31486

**PHASE 1 INSPECTION REPORT
NATIONAL DAM SAFETY PROGRAM**

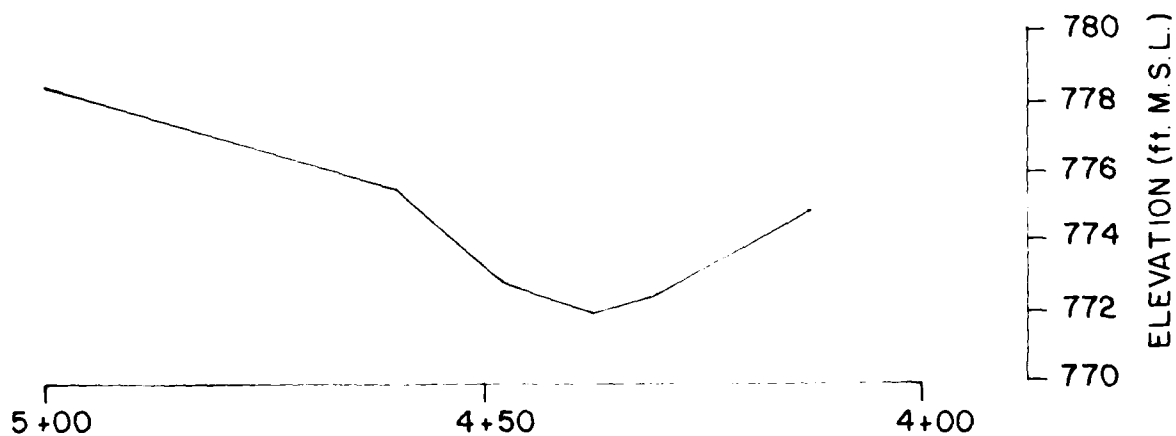
PROFILE & SECTION OF SPILLWAY

Information from the owner indicates that the spillway was originally lined with concrete from about 40 ft upstream of the crest to about 100 ft downstream of the crest. A large portion of this concrete has deteriorated and washed away in the last few years, leaving only a portion of the slab at the spillway crest. The remaining concrete is severely undermined at its downstream end (see Photo 13). The spillway discharge channel has experienced considerable erosion immediately downstream of the crest (see Photos 14 and 15). The spillway discharge channel is fairly clear for about 100 ft before entering a wooded area. It empties into the old streambed below the small pond beyond the toe of the dam.

No evidence of overtopping of the embankment was observed. The approach area to the spillways was filled with silt and wood debris. The concrete slab which protects the spillway section is severely undermined at its downstream end. The outlet channel has experienced significant erosion.

- (1) Seepage and stability analyses comparable to the requirements of the recommended guidelines should be performed by an engineer experienced in the construction of dams.
- (2) The spillway crest area should be provided with a permanent control section, which is protected against undermining. The downstream channel beyond the control section should be protected against erosion.
- (3) The erosion, sloughing, and animal holes on the upstream embankment face should be repaired, and wave protection should be provided.
- (4) Trees and brush should be removed from the face of the dam on an annual basis. The initial clearing should be done under the guidance of a professional engineer experienced in the design and construction of dams. Indiscriminate clearing methods could jeopardize the safety of the dam.
